THESIS

ROLLING CONTACT FATIGUE TESTING OF THERMOMECHANICALLY PROCESSED M-50 STEEL

Fred A. Butterfield, III

December 1984

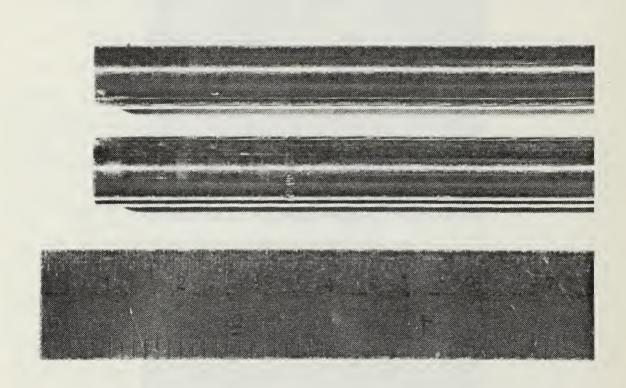
Figure 3.17 Rolling Contact Test Rods, As-Received: 1106°C (Top), 1006°C (Middle)

produced in the as-received material showed no difference in appearance from those occurring on the warm-rolled stock, and vice versa.

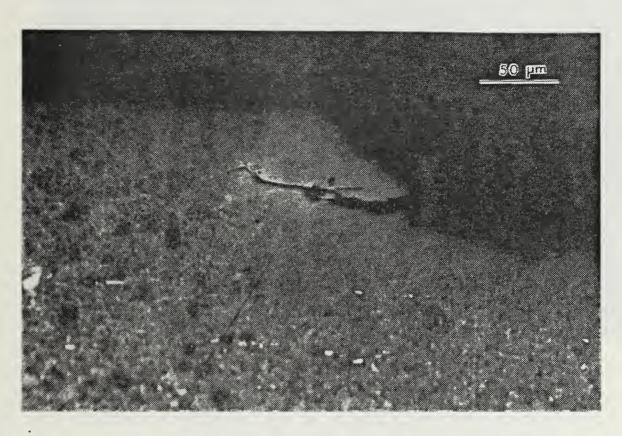
Figure 3.19 Sectioned Fatigue Spall: As-Received Material, Austenitized at 1106°C (406X)

Using optical microscopy, the microstructure below the surface of the spall was examined. The test rods were sectioned longitudinally, so that both the center of the spall and the direction of rolling (evidenced by strings of insoluble carbides) were revealed. Figures 3.19 and 3.20 (406X) depict failures which occurred in the as-received and the warm-rolled (700°C) material, hardened at 1106 and 1006°C, respectively. In neither case was there any obvious interaction between the residual carbides and the cracking which can be observed around the spall, nor was

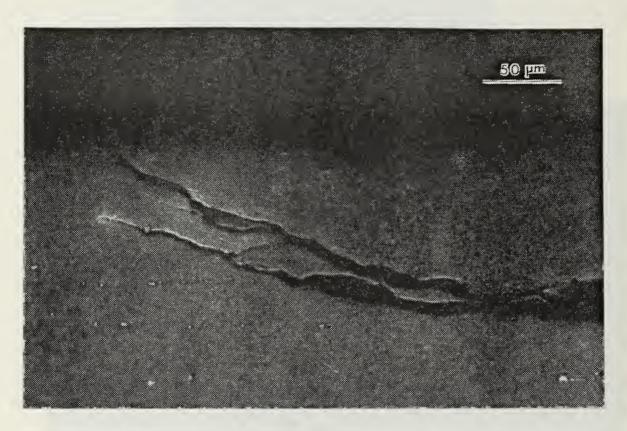
Figure 3.20 Sectioned Fatigue Spall: Warm-Rolled (700°C) Material, Austenitized at 1006°C (406X)

any association seen with the as-received material which had been austenitized at 1106°C (not pictured).

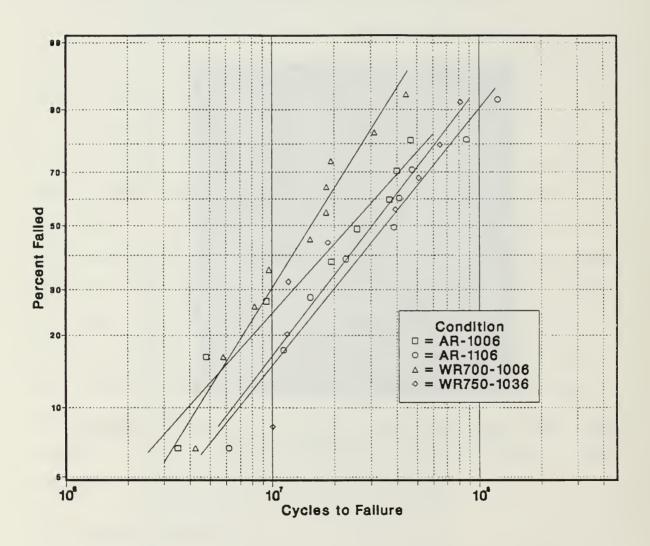
Figure 3.25 Weibull Distribution

Figure 3.25 shows all four test rods/conditions on a Weibull plot. Noteworthy is the fact that there are no vast differences in rolling contact fatigue life among the test conditions. The Weibull slopes for three of four rods are essentially equal, while the slope for the warm-rolled (700°C) material austenitized at 1006°C is inexplicably (and perhaps insignificantly) higher. Allowing for statistical scatter and the relatively small number of tests

run per sample, the results demonstrate virtual equivalence. This is particularly significant (and reasonable) in light of the similarities in microstructure and hardness which have already been documented for this material. Therefore, one must conclude that, for the heat treatments here with a five-minute austenitizing time, there appears to be no dependence of rolling contact fatigue behavior on prior processing history. Further testing in rolling contact fatigue must be conducted on materials which have been heat treated for shorter holding times. As noted previously, this may facilitate determination of the effects of microstructural refinement, assuming such refinement is better retained at the shorter austenitizing times.

However, neither can the effect of voids associated with the insoluble carbides be neglected. It is quite possible that, regardless of the microstructural enhancement gained by thermomechanical processing, cavitation is the controlling feature which determines the fatigue life of rolling elements fabricated from M-50 steel. If these voids act as stress raisers in the matrix, they would have the same propensity to act as sites for crack nucleation in the substructure as porosity or oxide inclusions. This condition effectively nullifies the benefits gained by VIM-VAR processing during manufacture of the steel, accomplished that these impurities might be removed [Ref. 17].

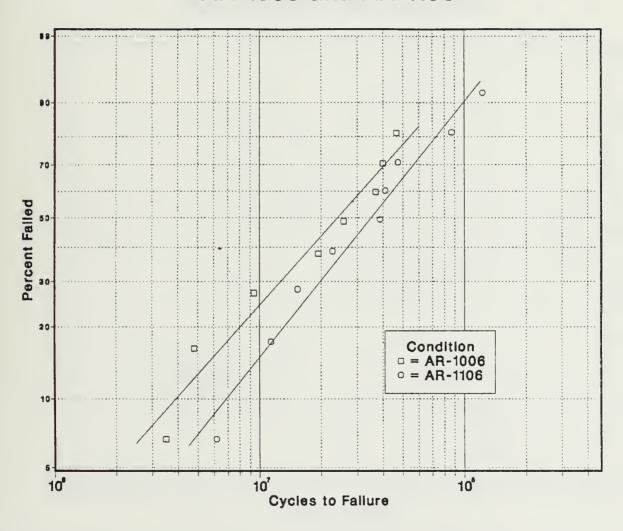
Figure 3.26 Weibull Distribution

Because the intricacy of Figure 3.25 makes it difficult to read, three additional plots were generated using the same data. Figure 3.26 compares the two as-received conditions. There it is observed that the material heat treated at the higher temperature clearly demonstrates a superior resistance to rolling contact fatigue. The mean life of the as-received material austenitized at 1006°C is 33.66 million cycles (Appendix A), compared with 45.81 million cycles for the same material hardened at 1106°C, an increase in average fatigue life of 36.1 percent. One would predict a greater resistance to rolling contact fatigue for the latter material simply on the basis that, at the higher austenitizing temperature, more carbides are dissolved and hence more carbon is taken into solution, yielding a harder microstructure. In reality, however, Rockwell readings for these materials, found in Table III, show that they are effectively identical in hardness, taking the standard deviation of the readings into account. So, even with an obviously inferior (larger) grain size, the as-received material austenitized at the higher temperature delivers a significantly better response in rolling contact testing.

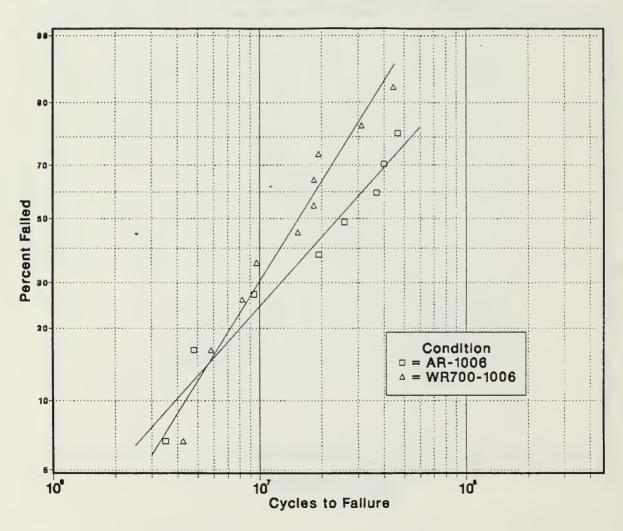
Figure 3.27 Weibull Distribution

The results from the as-received and warm-rolled (700°C) test rods, both austenitized at 1006°C, are shown in Figure 3.27. The data are very similar at the lower percentages of failure, but the as-received material outperformed the warm-rolled stock as the testing continued. The mean life

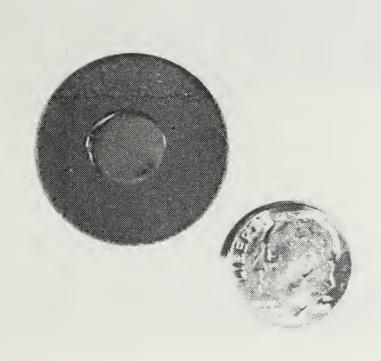
Figure 3.29 Longitudinal Cracking (Cross-Section): Warm-Rolled (750°C) Material, Austenitized at 1066°C

These cracks generally traversed the entire axial length of the test rod (about four inches) and penetrated to a range of depths, from less than 1 mm below the surface to the entire 0.375 inch (9.5 mm) diameter of the rod. An example of this extensive cracking is shown in Figure 3.29, which exhibits a sample of the warm-rolled (750°C) material, austenitized at 1066°C, mounted in phenolic compound and polished.

At first it was assumed that these cracks were the result of too rapid a quench from the austenitizing temperature. This idea of severity of quench was discarded, however, when further thought was given to the actual heat treatment (i.e., stabilization of the test rod in molten salt following austenitization, then air cooling to room temperature), which gave sufficient time for residual stresses to be accommodated in the material. Instead, it was

reasoned that the cracking must have resulted from the tempering treatment which followed hardening. Specifically, it was thought to occur during the first freezing cycle, when it was suggested that large quantities of retained austenite transformed to untempered martensite. This would be accompanied by an unfavorable volume change due to the lattice transformation from a face-centered cubic (FCC) crystal structure to a body-centered tetragonal (BCT) structure, which in turn would lead to cracking.

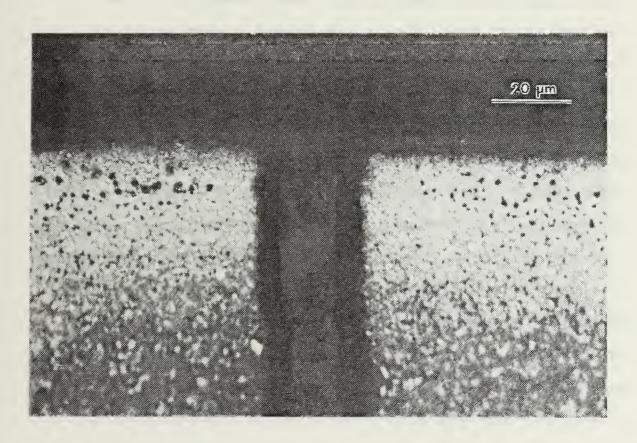
Figure 3.30 Warm-Rolled (750°C) Material, Austenitized at 1066°C (1016X)

This hypothesis was confirmed by optical microscopy. Figure 3.30 (the same specimen shown in Figure 3.29), shown at a magnification of 1016X, depicts the intersection of a crack with the surface of the test rod. A shallow decarburized layer can be seen at the rod surface, a common defect which occurs during austenitizing (final grinding removes this layer before commencing the rolling contact fatigue test). Decarburization is not evident in the crack, however, indicating that the fissure had not yet been opened during hardening. This result confirms the postaustenitization examination of the rolling contact specimens which found them to be crack-free. Figure 3.30 also reveals that both the rod surface and the crack interior show evidence of oxidation, such as would occur upon tempering. Thus, one concludes that cracking took place after austenitizing but before tempering: i.e., during the deep-freeze phase of treatment.

Retained austenite has been documented in the metallurgical literature as having a deleterious effect upon rolling contact fatigue life [Refs. 21 and 22]. Apart from austenite being a softer phase than martensite, there is always the danger that stresses generated in-service can activate a transformation to martensite. This will lead to volume and possibly shape changes (due to the change in lattice structure). Also, the presence of a local residual stresses could also assist in the initiation of fatigue cracking, decreasing the life of the component [Ref. 22].
